Manhole Inspection Summary

Manhole # S21MM1008MH

Location Address: **4462 LAPLATA AVE**

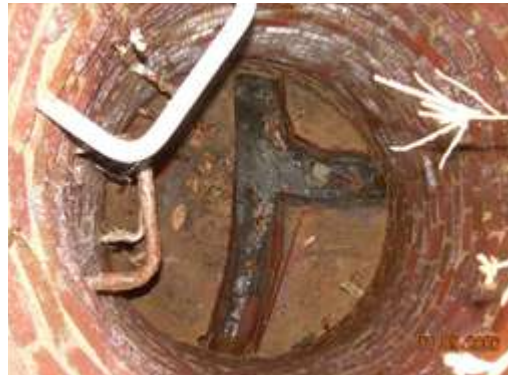
Top View

Corroded steps. Evidence of surcharge - Bench debris. Channel debris.

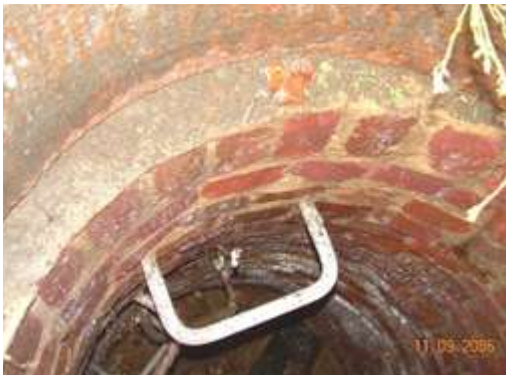
Defect

Frame offset. Adjustment, Corbel and Barrel infiltration.

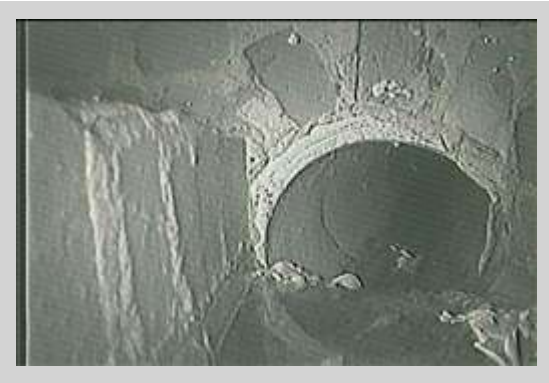
8 in. Circular Gravity Sewer Pipe Out @ 12 O'Clock

Invert Depth: **10.12** (ft.) Flow Characteristics: **Slow**

Deposits: ☐ None ☒ **Mud** ☐ Sludge ☒ **Debris** ☐ Grease

Silt Depth: **1** (in.) Deposits Extent: **Light**

Infiltration: **None** Pipe Seal Cond: **Unknown**

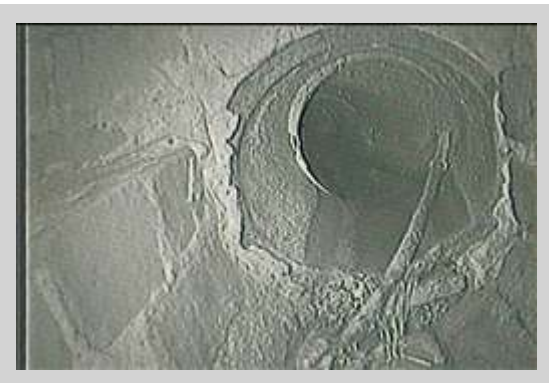
8 in. Circular Gravity Sewer Pipe In @ 3 O'Clock

Invert Depth: **9.55** (ft.) Flow Characteristics: **Slow**

Infiltration: **Evidence** Pipe Seal Cond: **Unknown**

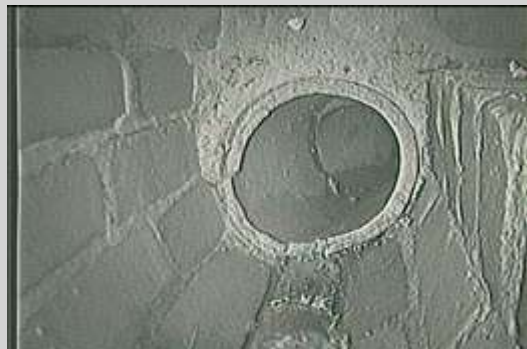
6 in. Circular Gravity Sewer

Infiltration: **Evidence**

Connects To: **Stub connection / abandoned**
